多时相数字孪生滑坡变形监测方法与应用研究

Multi-temporal digital twin method and application of landslide deformation monitoring: A case study on Baige landslide in Jinsha River

杨云建, 周学铖, 何中海, 等. 多时相数字孪生滑坡变形监测方法与应用研究——以金沙江白格滑坡为例 [J]. 水文地质工程地质, 2024, 51(2): 132-143.

多时相数字孪生滑坡变形监测方法与应用研究 ——以金沙江白格滑坡为例

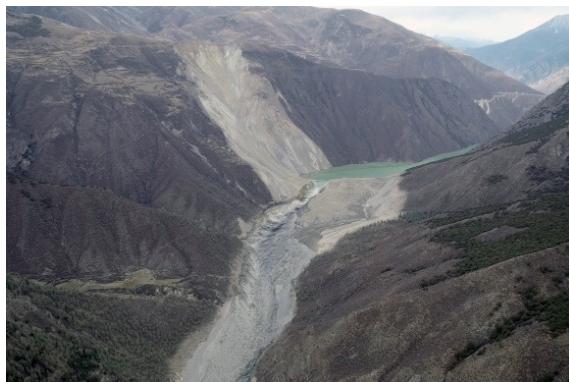
图1 白格滑坡泄洪全貌图

注:拍摄于2018年11月13日,镜向西北。

白格滑坡(图1)位于川藏交界的金沙江西侧,西藏自治区昌都市江达县白格村,堆积区涉及金沙江东侧的四川省甘孜藏族自治州白玉县。滑坡地处藏东横断山脉、金沙江流域的河谷地带,为典型的构造侵

蚀地貌,滑坡体后缘高程3 720 m,前缘金沙江水面高程2 880 m,高差约840 m,滑坡体后缘至前缘直线距离1.43 km,平均宽度550 m,主滑方向82°~102°^[21],两次滑坡形成的堆积体体积达千万立方米^[22],属于高位、远程特大型滑坡^[23]。

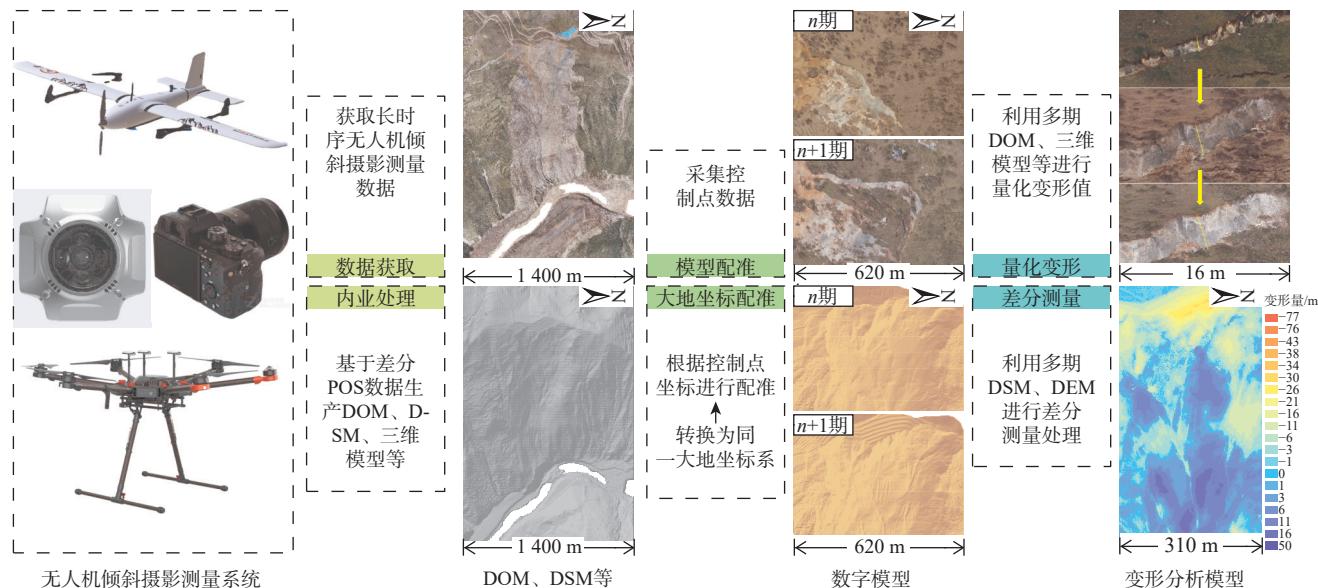
图2 多时相数字孪生滑坡变形监测方法

构建、利用多期次三维立体的数字孪生体获取灾害变形特征及时空演化规律,进行高精度定量分析及风险评估等方面。首先利用无人机倾斜摄影测量技术对滑坡区域进行长时序、多期次、高分辨率的数据采集;然后通过内业进行滑坡地形快速重建,且采用大地坐标配准法对多期成果进行配准后,基于二三维地理信息平台,将高分辨率的DOM、DSM、DEM、Mesh三维模型等多源数据融合构建三维立体的数字孪生滑坡体;最后通过智能解译、多期对比、空间分析、竖向差分测量^[30]等方法获取滑坡灾害发育分布特征,对监测区进行三维变形分析,监测滑坡体多维变形要素,综合分析滑坡体的稳定性和时空演化规律,开展风险评估。其监测方法主要流程如图2所示。

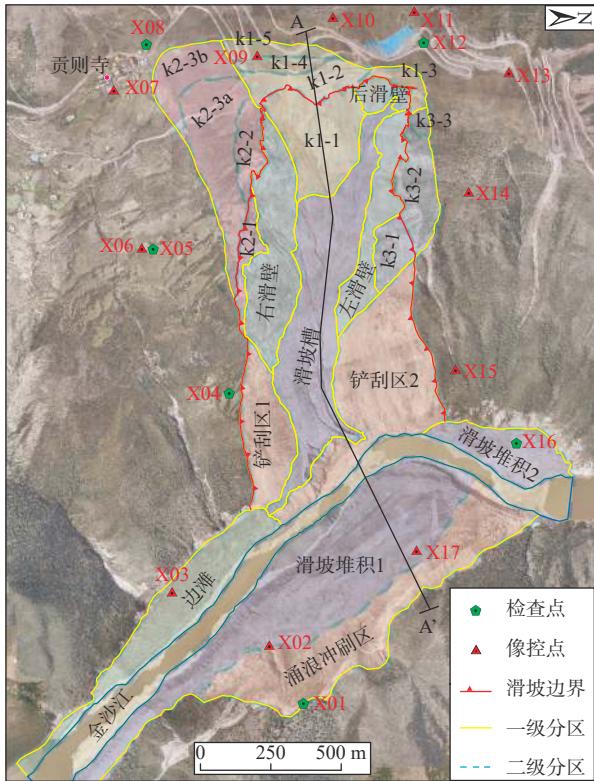
图3 白格滑坡监测分区(2021年9月28日正射影像)

以2021年9月28日数字孪生体为基准,结合应急抢险时滑坡残留体、裂缝分布及持续变形情况对白格滑坡进行监测分区,涵盖了滑坡堆积区、后缘变形区、左侧变形区、右侧变形区、滑壁滑坡槽等5个监

测大区, 23个监测亚区, 白格滑坡监测分区分布如图3所示。

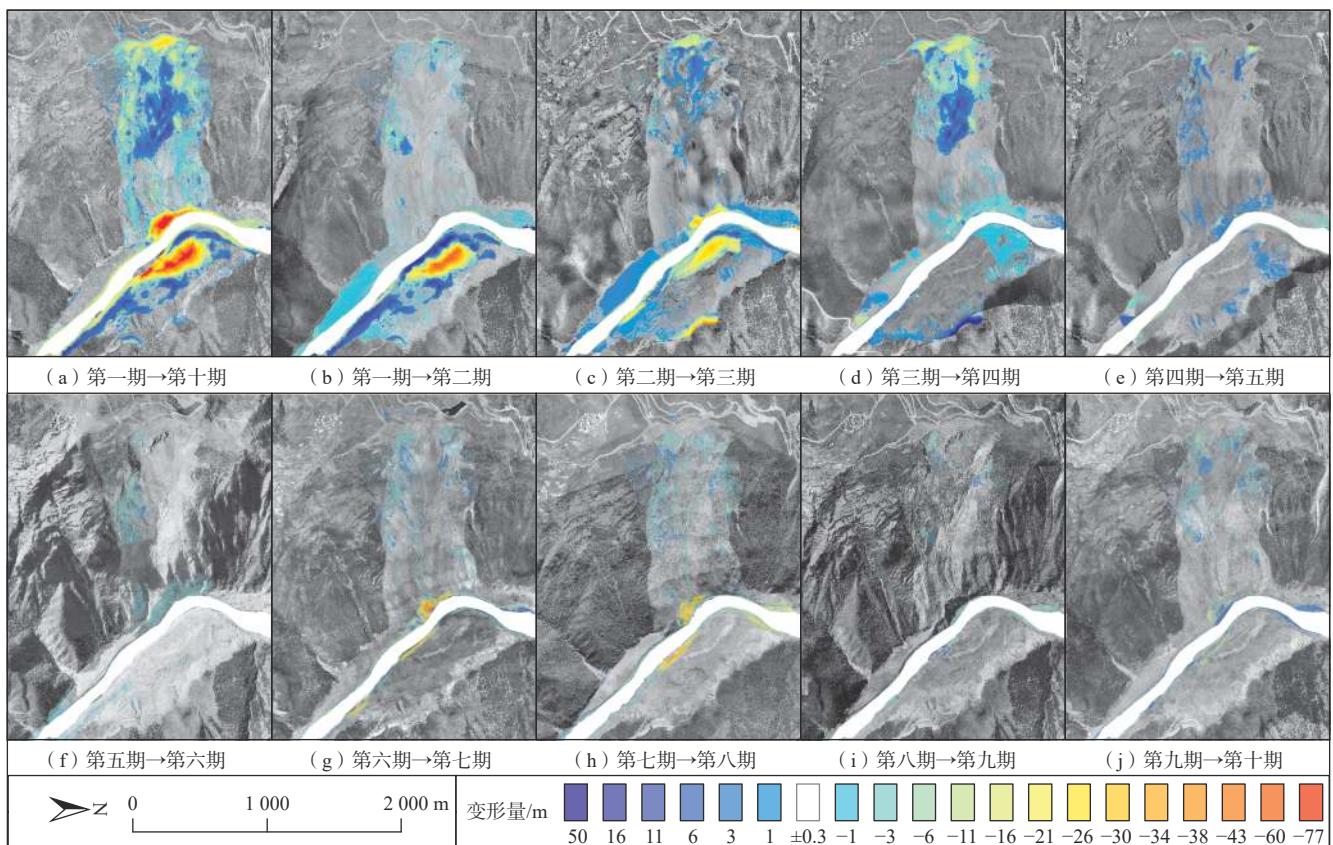
图4 滑坡体长时序变形图(2019年4月26日—2021年9月28日)

对2019年4月26日—2021年9月28日共10期数字孪生滑坡体进行差分测量, 获取了监测区3年的时空变形数据(图4), 并识别了滑坡体在本次监测区段内存在的变形区域和地表变形量。

白格滑坡成灾后, 救援力量于2019年4月26日—2019年9月25日(一至四期)对滑坡后缘强变形区进行减载施工, 对滑坡堆积1区域堆积体进行减载施工、疏通河道, 每期差分变形迹象明显。经应急排险工程干预, 消除了部分潜在危险, 但仍有大量物源存在垮塌风险, 通过监测分析表明, 白格滑坡强变形区域主要集中在后缘残留体K1、K2、K3区域。

K1变形区位于滑坡后缘顶部, 受两次滑动牵引, 虽然经人工减载消方, 但变形迹象仍然明显, 其前缘滑坡壁陡峭, K1-1、K1-2、K1-3区受重力等影响出现下错变形及多处溜滑垮塌; K2变形区位于滑坡边界右侧, 受两次滑坡牵引及刮铲, 滑坡临空面增大且较

为陡峭, K2-1、K2-2区发育大量裂缝, 出现下错变形及发生小规模溜滑垮塌; K3变形区位于滑坡边界左侧, 临空条件好, 受重力影响K3-1区块体已逐渐分解破碎滑塌, K3-2、K3-3区发育众多裂缝, 块体逐渐被裂缝分解破碎, 滑塌趋势明显; 滑壁及滑槽堆积大量后缘残留体滑塌岩土, 在自重作用下, 向下蠕滑, 同时受降雨冲刷形成大量冲沟, 且深度和宽度不断扩大的。

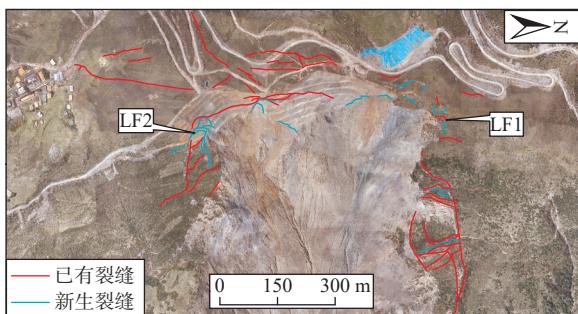
图5 裂缝发育分布图

监测显示, 白格滑坡在监测期内的活动方式以蠕滑为主, 主体表现为老裂缝的宽度与深度不断加大, 新裂缝不断滋生, 局部伴随小规模的垮塌与渗水等现象(图5)。

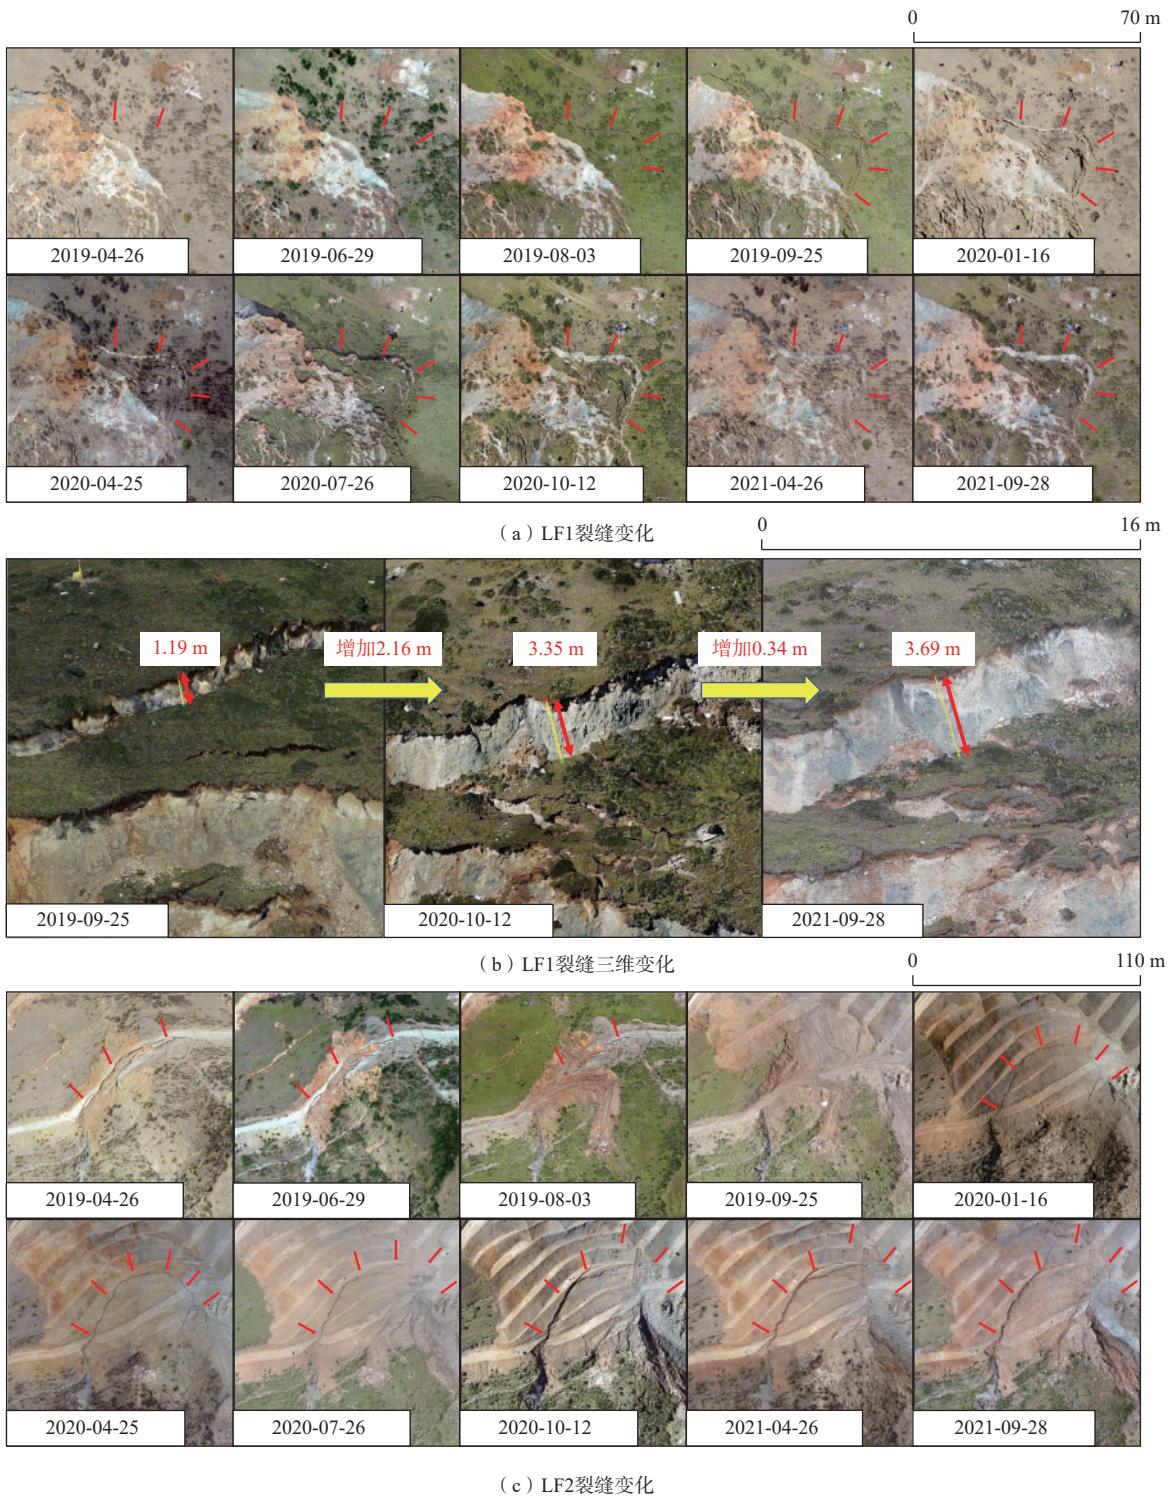
图 6 裂缝变化图

2019年4月26日—2021年9月28日, 白格滑坡后缘新增裂缝总长1 075 m, 裂缝总长度超过5 377 m。其中位于后缘K1-3监测亚区的裂缝(LF1)和K2-2亚区的裂缝(LF2)变形特征最为典型。

空间上, LF1的长度从第一期43 m增加到第四期53 m后, 受地形限制长度不再增加, 但变形一直在扩大, 水平变形量从0.1 m增加到2.06 m, 竖向变形量从0.08 m增加到3.69 m; LF2于第五期监测发现, 至第十期水平变形量达2.72 m, 竖向变形量达3.6 m(图6)。

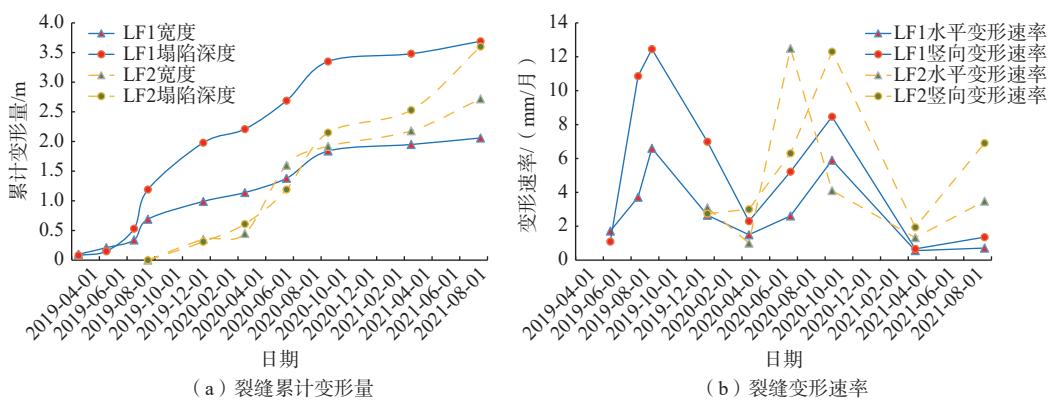
图 7 裂缝变形及趋势图

时间上, LF1在2019年4月26日—2019年6月29日期间较为稳定, 于2019年8月3日—2020年10月12日存在一个快速变形的过程, 之后趋势有所缓和, 但仍在持续变形; LF2于第五期(2020年1月16日)监测发现, 夏季降雨期变形速率远高于冬季枯水期, 且第十期变形时序曲线演化趋势尚未脱离线性(图7)。

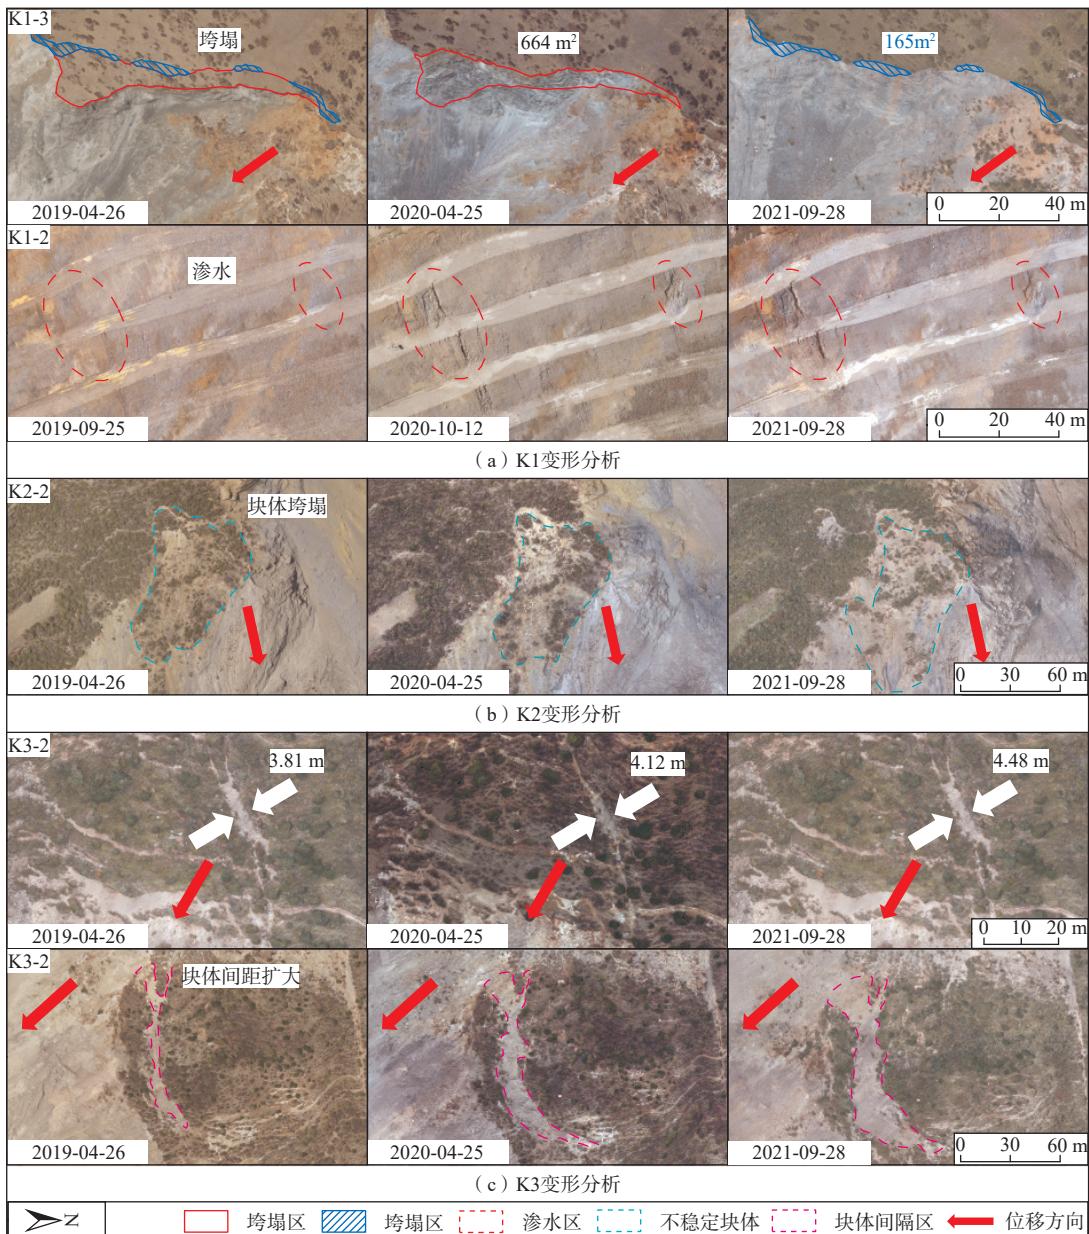
图 8 变形区量化分析图

位于K1-3裂缝LF1旁边的变形区可见明显垮塌, 崩塌面积达到829 m²。同时在人工减载后的K1-2区域存在大量渗水迹象, 减载台阶出现垮塌; K2-2靠近滑坡壁外侧块体在持续向沟底搓动, 平均移动速率达到每月5.88 m, 且块体已经出现分解垮塌迹象; K3-2位于滑坡壁外侧, 整个块体处于不稳定状态, 侧翼剪张裂缝在不断发展扩大, 边缘不稳定块体与滑坡壁间距逐渐扩大, 且滑坡壁出现密集裂缝; 另外, 滑壁及滑槽受雨季雨水冲刷, 形成了若干条冲刷沟槽, 最大宽度达到33.83 m, 最大深度达到14.78 m, 大量土方顺着沟槽冲入金沙江, 河岸两侧的铲刮区和滑坡堆积区受江水冲刷其垮塌面积达到30 161 m²(图8)。

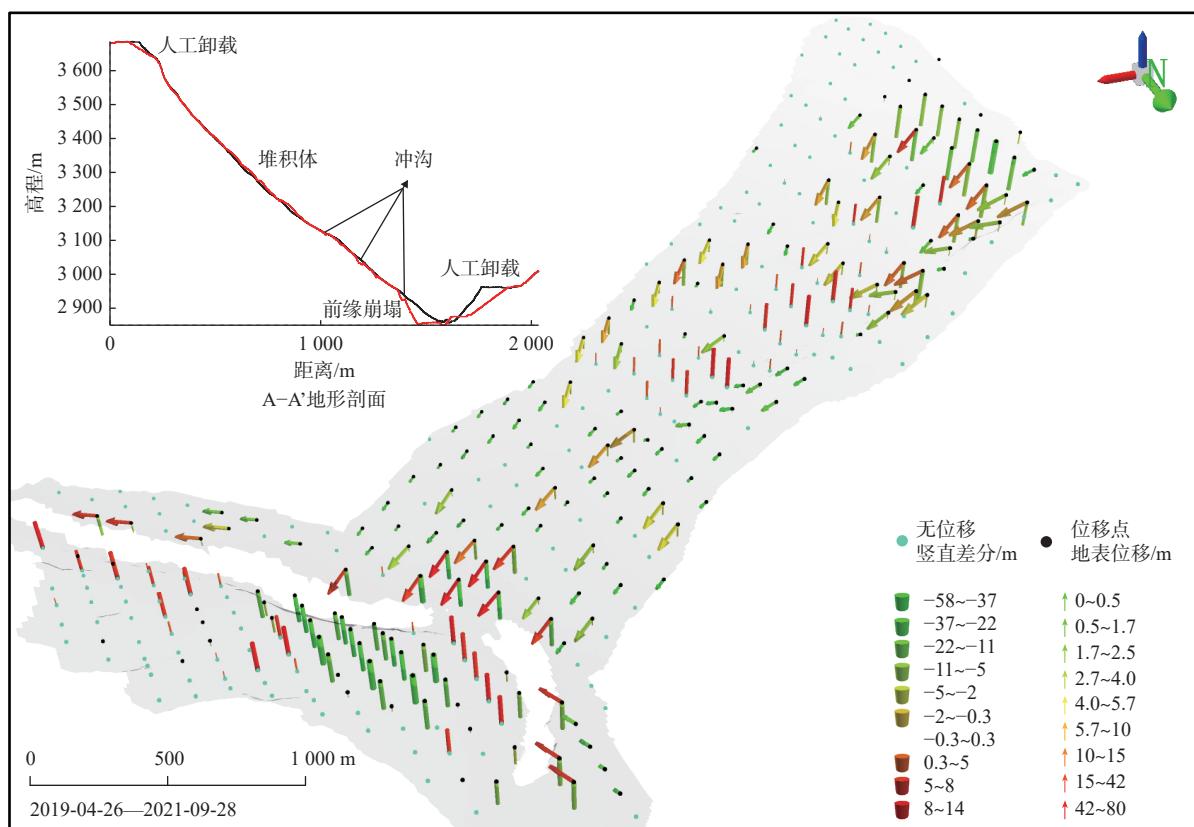
图 9 滑坡体地表三维变形图

利用2019—2021年多时相数字孪生滑坡体跟踪测量了滑坡体地表数百个特征点的空间位移量及移动方位等信息,结合滑坡体竖向差分模型绘制了滑坡体地表三维变形图(图9)。

整体上,白格滑坡K1区后缘经施工减载后,部分区域虽有较明显的宏观变形,但强变形体规模不大;K2、K3区变形迹象明显,裂缝不断发育增加,后缘不断出现垮塌,部分残留体逐渐分解破碎滑塌,其中LF1裂缝水平变形速率最大可达每月1.98 m、垂直变

形速率最大可达每月3.735 m,LF2裂缝水平变形速率最大可达每月3.75 m、垂直变形速率最大可达3.692 m/月,K2-2变形块体平均移动速率达到每月5.88 m,且有加速变形迹象。综合滑坡体地表三维变形情况,在极端工况下存在变形区失稳滑坡风险。

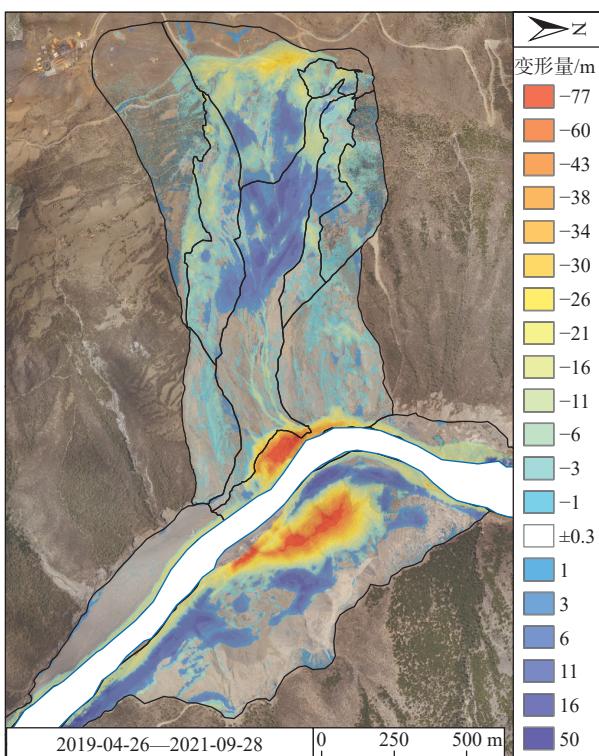
图 10 滑坡体已滑变形分析图

DSM差分结果表明(图10),2019年4月26日—2021年9月28日,滑坡后缘人工卸载区,平均消减厚度达到20 m,减载 42×10^4 m³岩土;K1、K2、K3等3个变形区共计自然垮塌 69×10^4 m³岩土,垮塌最大厚度18 m,同时有 27×10^4 m³岩土堆积在该区域下部边缘;滑坡槽累计堆积了 52×10^4 m³岩土,其中包括 42×10^4 m³人工削坡滑落堆积的岩土和实际因变形坍塌的 10×10^4 m³岩土,局部堆积厚度达16 m,受雨水冲刷形成多条冲沟,截至2021年9月28日冲沟最深处达到14.78 m,累计冲刷带走 33×10^4 m³岩土;铲刮区2因金沙江长期冲刷,导致坡面底部受力失稳,产生崩塌,崩塌最高处距江面79.5 m,崩塌累计体积 90×10^4 m³岩土;堆积区1通过人工减载 268×10^4 m³岩土,削减堆积体高度61 m

白格滑坡体在3年内经应急施工减载和变形滑塌等地形变化,总计有 $800 \times 10^4 \text{ m}^3$ 的体积变化,其中后缘、滑坡壁、前缘等区域变形滑塌 $248 \times 10^4 \text{ m}^3$ 的岩土,部分堆积在滑坡槽形成堆积体,在降雨期因饱水呈流
