**Current situation and scientific challenge of soil and water erosion in Gully Consolidation and Highland Protection Project of DongZhi Loess Plateau**

## 董志塬区固沟保塬工程水土侵蚀病害现状及科学挑战

2023 年 3 月 15—19 日, 通过对庆阳市董志塬地区小崆峒沟、火巷沟、李家寺沟、安家寺沟、驿马镇北胡同沟等典型固沟保塬工程水文过程调控措施考察, 详细调查了典型固沟保塬工程当前遭受的水土侵蚀病害发育特征。在野外工作的基础上, 讨论当前固沟保塬工程中水土侵蚀病害研究面临的科学挑战, 为未来固沟保塬工程水土侵蚀病害防治提出可行建议, 以期为今后固沟保塬工程建设模式创新提供借鉴。

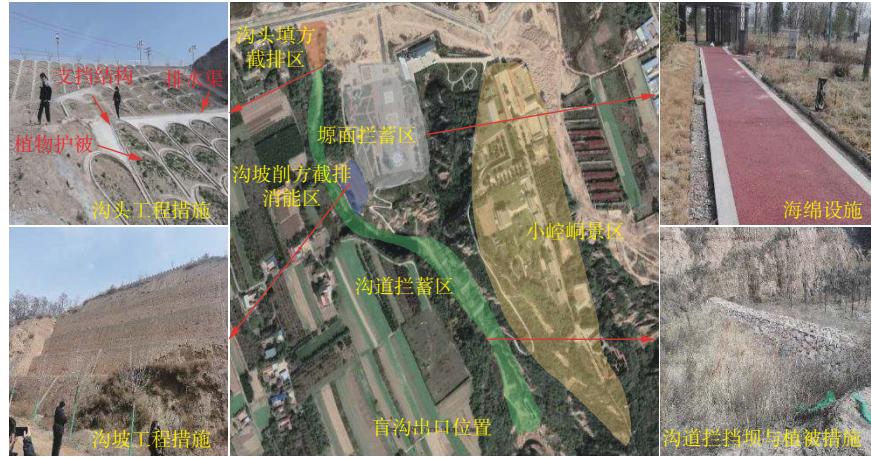
在流域不同位置固沟保塬工程水文调控功能存在显著差异, 按照水文调控功能将固沟保塬工程分为塬面拦蓄区、沟头填方截排区、沟坡削方截排消能区和沟道拦蓄区, 如图 1 所示。

图 1 固沟保塬工程水文调控功能分区 (小崆峒地质公园)

Fig. 1 Hydrologic control function zones of GCHP (Xiaokongtong Geopark)

池、海绵设施(图 1)等。拦截设施通过截断下塬径流路径实现水文过程调控, 主要设施包括边埂、梯田和塬边截水渠。拦蓄区可以有效拦截和储蓄塬面径流, 减小沟头径流直接排放, 塬面蓄水通过下渗和有序排放至沟道, 以减缓径流对沟头的冲刷。

沟头填方截排区(图 1)主要“控水”措施有截排水渠、盲沟、生物措施及边坡支挡工程等(图 2)。截水渠主要截留上级边坡径流, 然后通过排水渠泄到坡脚的排水沟。盲沟主要用于排泄填方区的地下水, 实现对地下水的人为调控, 以降低填方区地下水的潜蚀作用。沟头填方区坡面一般还会配套生物措施, 减少降雨和径流对坡面的溅蚀和冲蚀作用。边坡支挡工程主要用于防止填方区发生重力失稳。

沟道水文调控措施主要有排水渠、谷坊、拦挡坝等(图1,图4)。这些措施可以降低沟道径流速率,进而减少对沟道两侧斜坡的侧蚀,谷坊和淤地坝可以拦

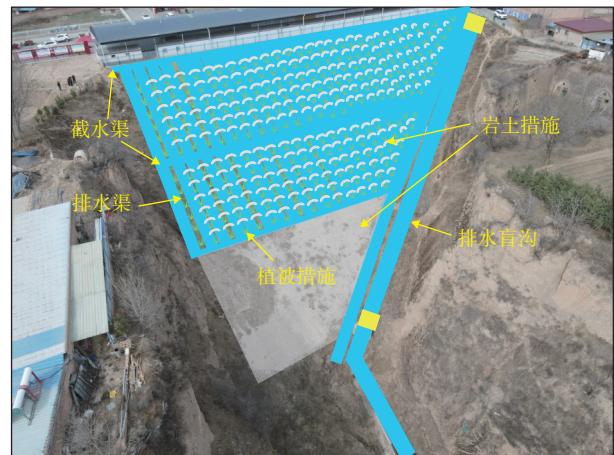
图 2 典型沟头填方截排水区 (驿马镇北沟)

Fig. 2 Typical ditch head filling and cut-off drainage area (Yima Town North Ditch)

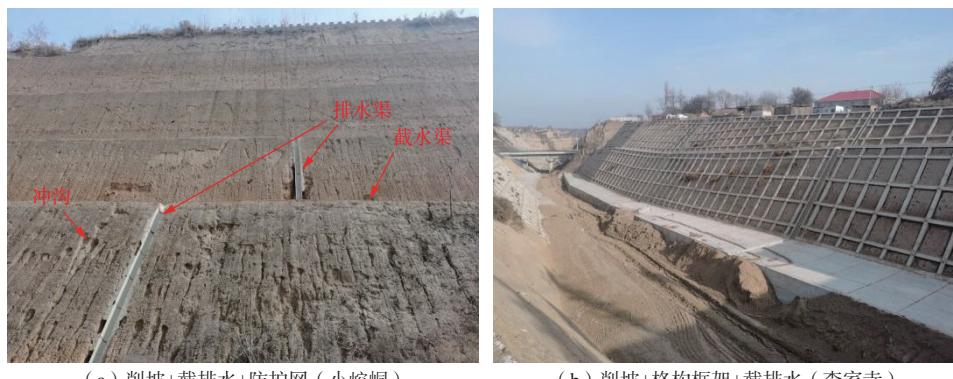
沟坡削方截排消能区的水文调控设施主要有截水渠、阶梯状消能排水渠、消能池和排水渠(图 3)。

截水渠主要截留上级边坡坡面径流, 阶梯状消能排水渠一般用于高陡边坡, 可以减缓上级台阶径流向下流动过程中的动能, 降低对边坡土体的溅蚀和溢流冲

图 3 沟坡截排消能区

Fig. 3 Slope cut-off drainage energy dissipation area

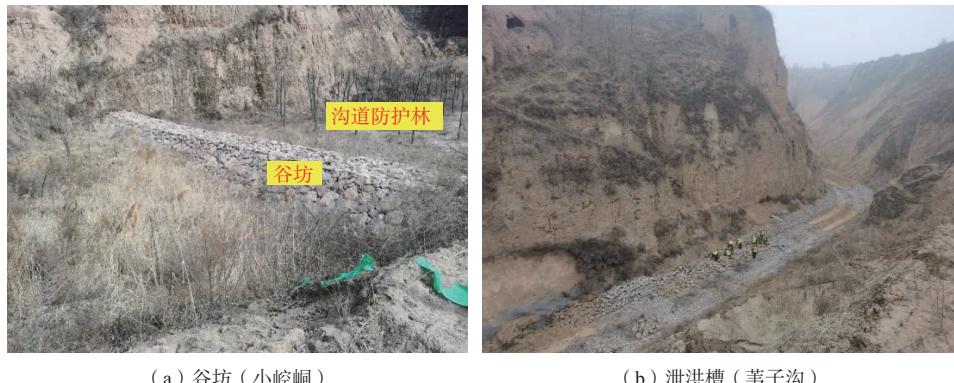
截上游泥沙,减少水土流失。沟道拦蓄区一般会结合生物防护林等进行综合治理。如,小崆峒沟小流域共修建4道重力式拦挡坝和4道柳谷坊,重力式拦挡坝和柳谷坊间互排列,在各坝之间种植柳树等植被,形成了综合拦蓄体系。

图4 沟道拦蓄区

Fig. 4 Trench holding area

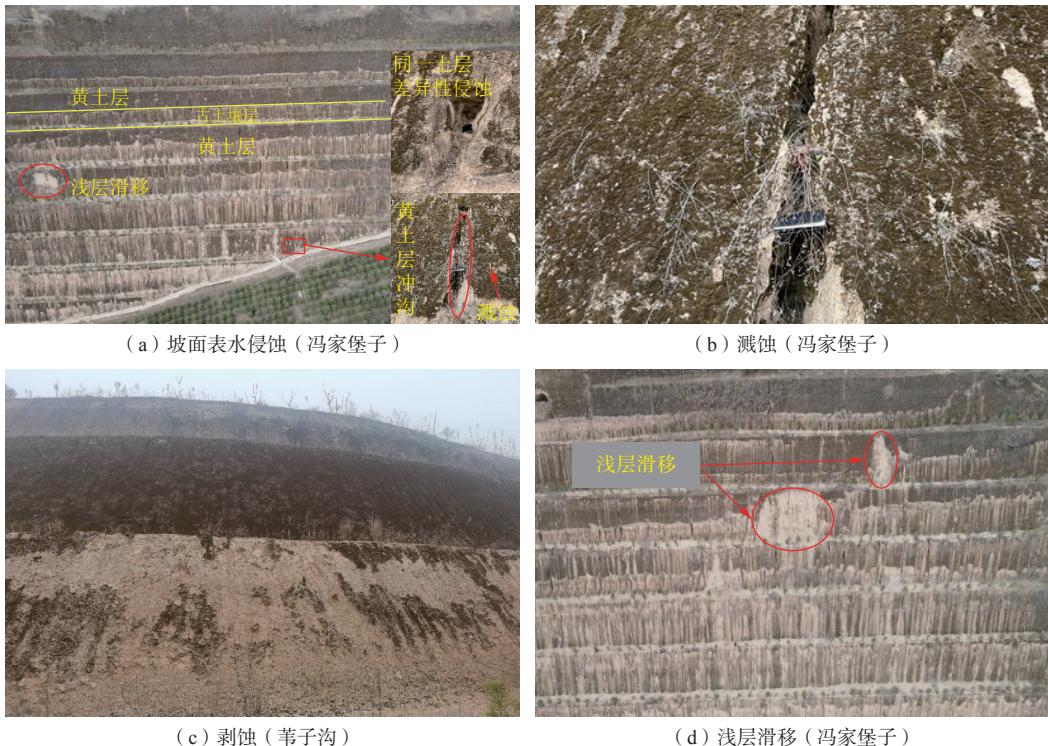
坡面表水侵蚀是削方斜坡最常见的侵蚀病害(图5a),通常发生在沟坡位置。在冯家堡子削方斜坡调查发现,坡面表水侵蚀存在差异性特征<sup>[11]</sup>。具体表现为:从上至下不同地层差异性侵蚀和从坡面向坡内的同一土层不同风化程度的差异性侵蚀。地层侵蚀差异性表现在黄土地层以冲沟侵蚀为主,冲沟窄且深度较

大;而古土壤层以面蚀为主,冲沟发育较浅,在有构造节理发育的古土壤层中,冲沟发育较深(图5a)。

溅蚀主要表现为鱼鳞状的小坑(图5b),小坑边可见溅蚀后落下的土颗粒。在地衣苔藓发育的部位,溅蚀量大大降低,可见地衣苔藓对坡面防护具有较好的作用。

图 5 坡面、坡脚表水侵蚀病害

Fig. 5 Surface water erosion diseases of slope surface and slope foot

环、冻融循环及昼夜温差共同作用下,发生膨胀碎裂,最终发生剥落,如图 5(c)所示。另外,也有因为坡面径流冲刷造成的小规模剥蚀发生,但是并不显著。

浅层滑移主要是降雨作用下,边坡上节理裂隙发育的部位快速充水饱和,进而发生浅层滑移破坏,如图 5(d)所示。

剥蚀与浅层滑移的区别在于:剥蚀掉落的土块碎散分布,呈碎片状,土质粗糙,棱角分明,自然堆积在坡脚,后壁粗糙;而浅层滑移下落的土块整体性较好,土质绵软,后壁可见有清晰的滑动痕迹。

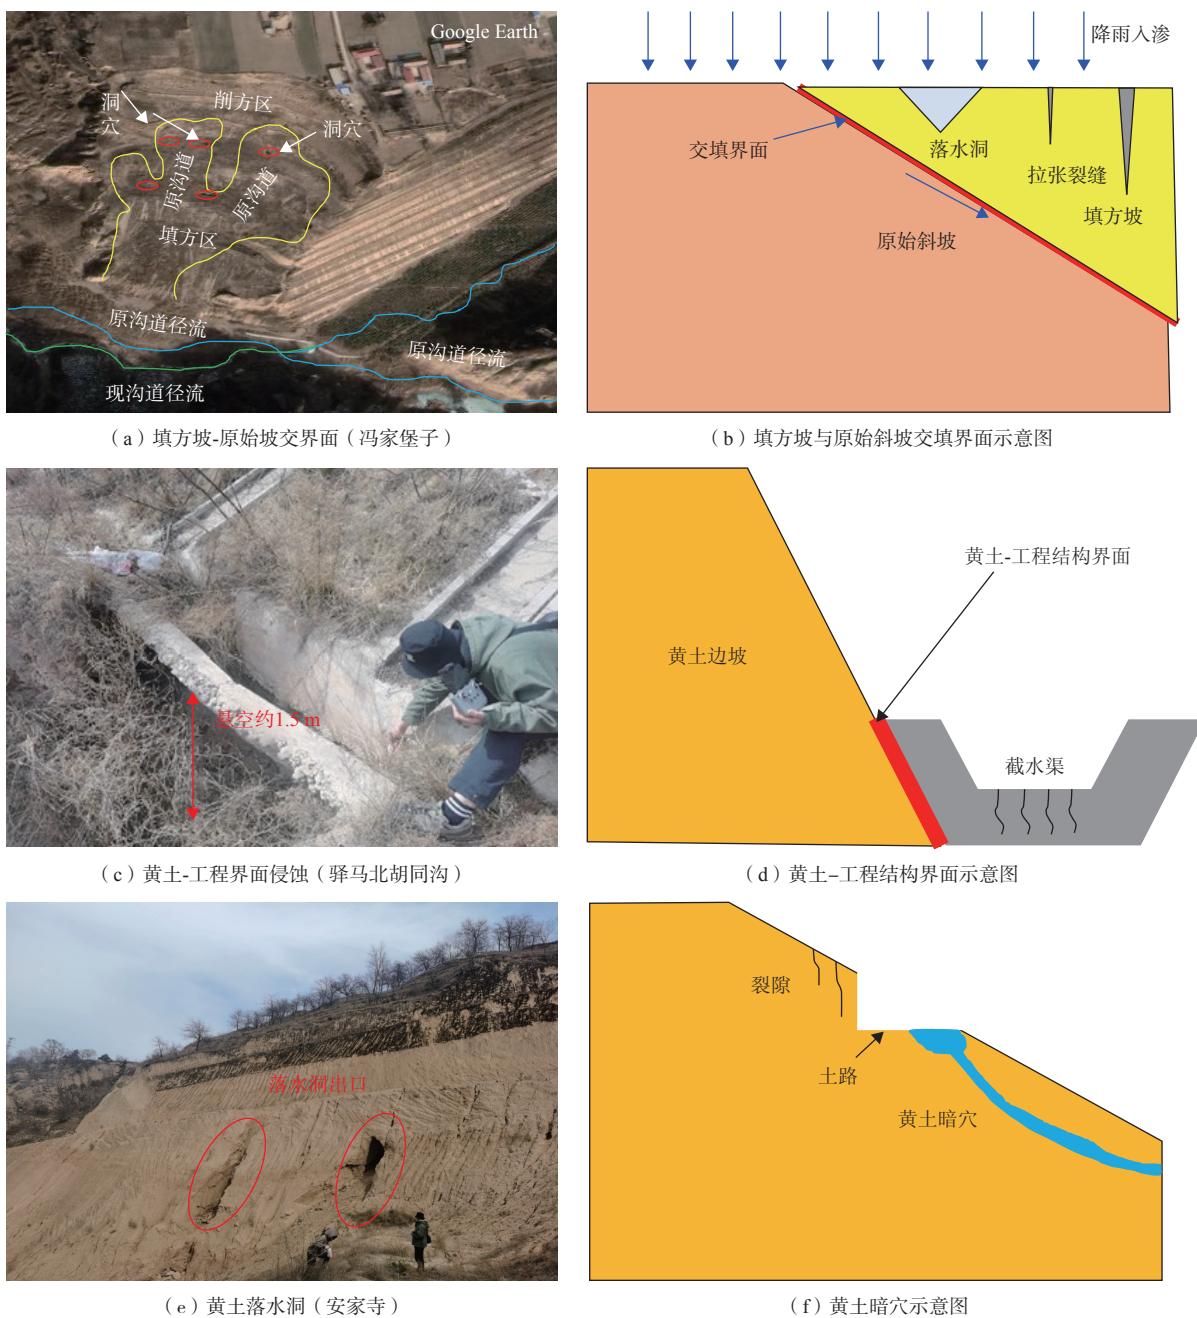
工程地质界面是指地层中受自然营力和工程活动共同作用的两种或多种介质之间的接触面,以及对三相介质迁移、物态变化和岩土体稳定性起控制作用的转换面<sup>[12]</sup>。黄土工程地质界面具体包括黄土与其他地层或堆积物接触界面、黄土内部宏细微观结构界面以及黄土与工程结构交界面等三大类。笔者通过野外实地调查发现,固沟保塬工程中常见的黄土工程地质界面有:填方体与原始斜坡交界面、黄土与工程结构交界面以及黄土内部多尺度结构界面(图 6)。这些黄土工程地质界面控制着固沟保塬工程和黄土体中水分的运移过程,影响着黄土内部水土灾变过程,因

黄土与工程结构交界面属于软硬介质交界面(图 6 c、d)。黄土节理裂隙发育,具有强烈湿陷性,遇水极易发生湿陷、崩解、软化和变形<sup>[16]</sup>,而工程结构尤其是混凝土结构具有相对于黄土较高的强度和抗侵蚀性。介质差异造成黄土与工程结构交界面极易发生

图 6 黄土工程界面潜蚀病害典型案例及示意图

Fig. 6 Typical cases and schematic diagram of subsurface erosion diseases on loess engineering interface

冲刷潜蚀病害<sup>[17-18]</sup>。调查过程中发现,固沟保塬工程中径流沿截水渠、排水渠以及岩土支撑结构外侧黄土-工程结构界面处发生冲刷潜蚀,造成了极为严重的损坏。冯家堡子沟道综合治理修建的排水渠已被径流冲刷临空或悬空,局部黄土-工程界面处径流冲刷潜蚀深度达1.5 m,部分排水渠因底部黄土被潜蚀掏空发生悬空折断。

特性。其中微观优势渗流界面指黄土中的大孔隙;细观优势渗流界面指节理裂隙、断层及根孔、虫孔;而宏观优势渗流界面指开放性裂缝和落水洞<sup>[19-21]</sup>。董志塬边节理裂隙等细观界面极为发育,且存在大规模落水洞群。地表径流沿节理裂隙等快速垂向入渗,不断冲刷裂隙壁面,在古土壤层等渗透性较差的地层附近发生侧向流动,最终从坡面流出斜坡,如图6所示,径流沿土路流动过程中,遇到黄土节理裂隙,转为垂向运动,遇到古土壤层后又转为侧向运动,最终冲

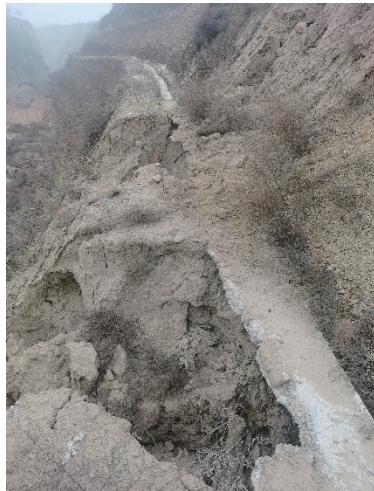
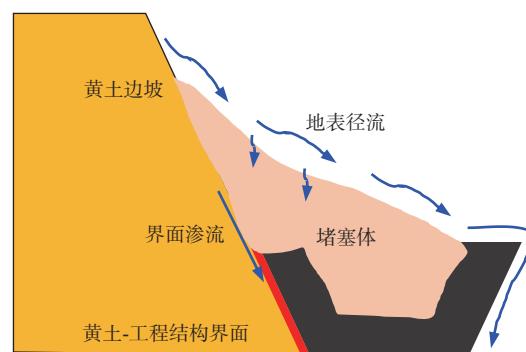
堡子多级台阶上原有的截水渠已被土体完全掩埋;苇子沟截水渠由于上部斜坡长期剥蚀和浅层滑移,导致截水渠中断,在径流冲刷淘蚀下发生悬空失效(图 7)。截排水渠的局部淤积堵塞还会造成渠道内大量积水,积水沿黄土-工程界面入渗导致浅层滑移病害。

(a) 截水渠堵塞

(b) 截排水渠堵塞示意图

图 7 截排水渠堵病害典型案例及示意图

Fig. 7 Typical cases and schematic diagram of blockage in cut-off drainage channels

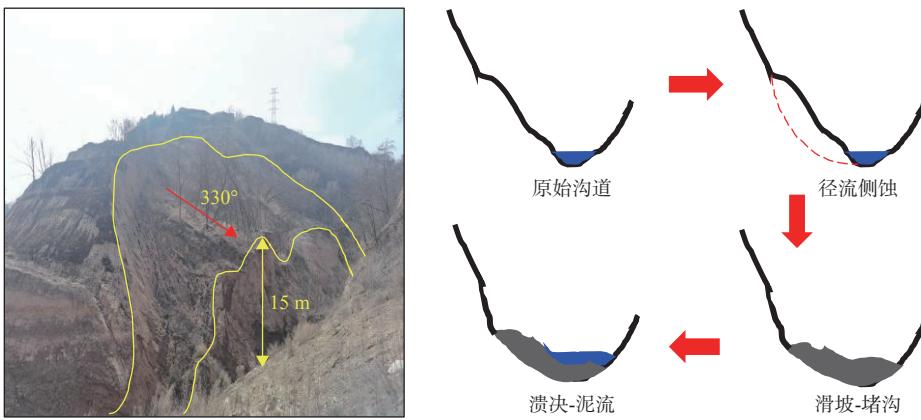
在固沟保塬工程中常对不稳定沟坡进行削坡处理,但是削方斜坡一般仅配套相应的截排水措施和植被措施,甚至仅是简单的植被措施。这些未施加岩土工程措施保护的黄土边坡的坡脚常年遭受严重的径流侧蚀,导致坡脚前缘临空,加之坡脚毛细水的上升导致土体强度降低,最终发生较大规模的黄土边坡滑塌病害(图 8)。由于沟道较为狭窄,滑塌的堆积体又会造成沟道堵塞形成黄土堰塞湖,进而演变为堰塞湖-溃决洪水-黄土泥流地质灾害链<sup>[22]</sup>,严重威胁下游安全。另外,堰塞湖的溃决又具有明显的“放大效应”,进一步加剧下游沟道斜坡的侧蚀和滑塌灾害。

图 8 黄土沟坡滑塌-堵溃-洪水灾害链

Fig. 8 Disaster chain of sliding, plugging, and flood of loess gully slope

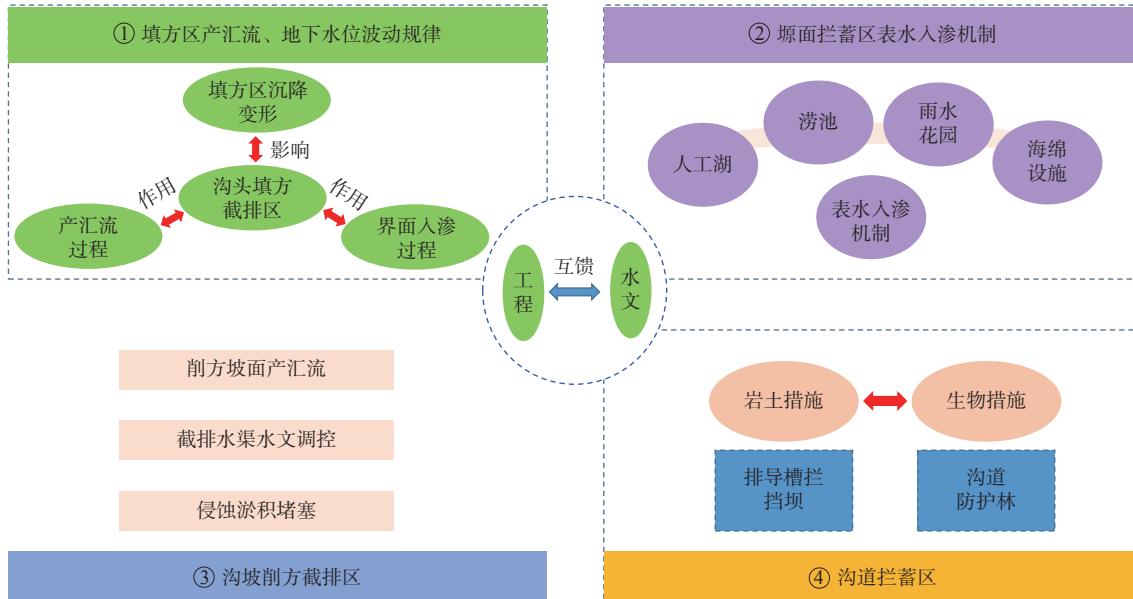
固沟保塬工程干预了沟头的水文过程(图 9)<sup>[23-27]</sup>,然而各类固沟保塬工程对水文过程的调控机制尚不清楚。例如,沟头填方区坡面产汇流机制不清,未充分考虑填方区岩土工程措施和生态植被措施等与水文过程的互馈作用。塬面拦蓄区积水主要以哪种方式排泄,长期积水塬面是否会对塬区地质环境产生负

图 9 固沟保塬工程与水文过程互馈作用

Fig. 9 Interaction between GCHP and hydrological processes

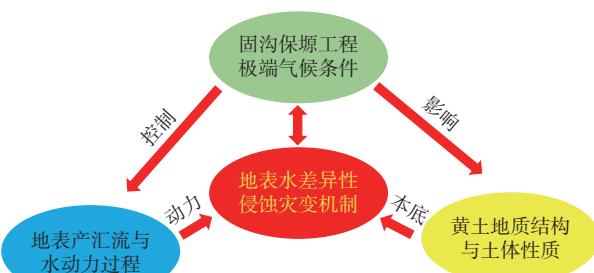
极端气候条件和人类工程活动双动力耦合互馈是固沟保塬工程中人工边坡表水侵蚀病害的控制性因子,边坡产汇流与水动力过程是动力条件,而黄土本身特殊的地质结构和强烈的水敏性是差异性侵蚀灾变发生的本底因素(图 10)。今后在人工黄土边坡

图 10 人工黄土边坡表水差异性侵蚀灾变主控因子

Fig. 10 Main controlling factors of surface water differential erosion disaster of artificial loess slope

表水侵蚀病害防治研究方面,需要更加充分地考虑黄土地质结构及水敏性对黄土表面侵蚀的控制机制;在此基础上充分考虑人工边坡上野生苔藓等生物土壤结皮的护坡效果<sup>[29–32]</sup>,通过人工种植地衣苔藓实现人

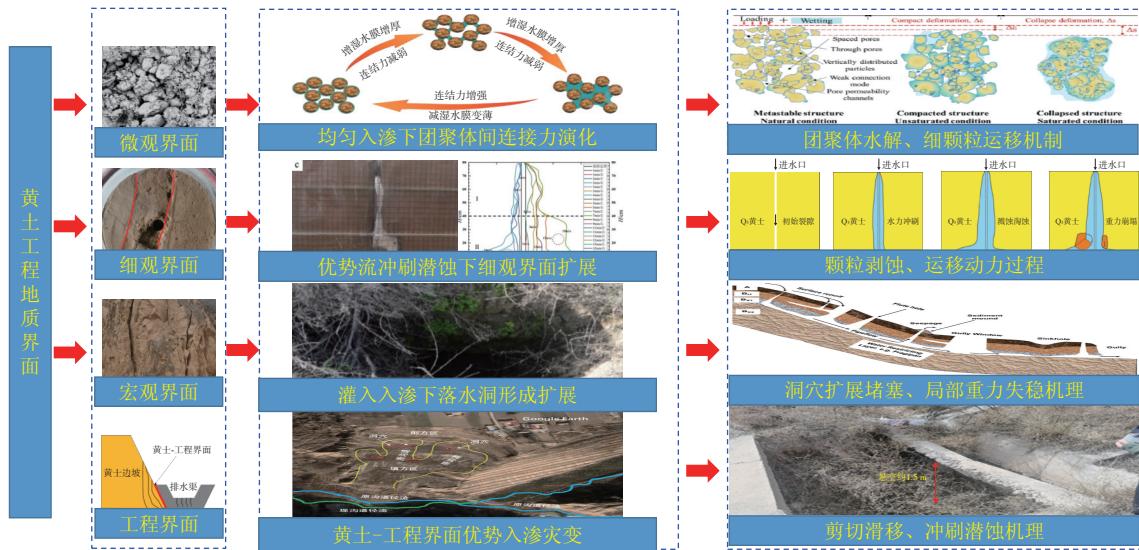
究黄土-工程界面、黄土内部界面和交填界面中复杂的土-水、土-结构耦合机制;通过裂隙性黄土潜蚀机理模型试验和数值计算方法等揭示水分在3大类界面中的运移规律;通过黄土工程地质界面渗透潜蚀试验等查明3大界面中潜蚀病害发生的临界条件和主控因素,为后期固沟保塬工程提供理论支撑(图11)。

图 11 黄土工程地质界面潜蚀灾变机理<sup>[34~36]</sup>

Fig. 11 Mechanism of subsurface erosion disaster at the engineering geological interface of loess<sup>[34~36]</sup>

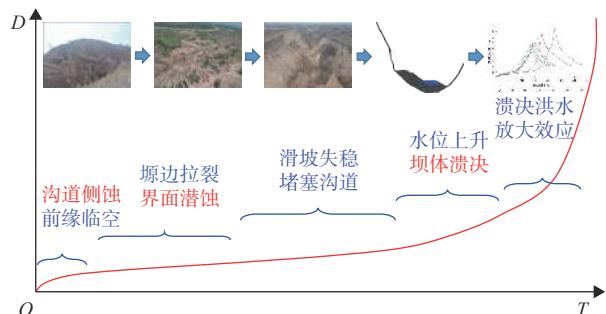
黄土侵蚀是遍布于固沟保塬工程中的关键外动力地质过程,尤其是在黄土沟谷地质灾害链中扮演着重要角色。由于大规模生产生活污水的排放导致沟道径流量常年处于较高水平,加剧了沟道侧蚀和溯源侵蚀,造成沟坡前缘临空;斜坡应力场重分布后,会造成塬边大规模开裂,降雨及地表径流沿拉张裂缝等界面入渗会造成严重的潜蚀病害。随着沟道侧蚀的进一步加剧,沟坡崩滑失稳<sup>[37]</sup>,形成堰塞坝堵塞沟道;随着库水位的上升,面临漫顶或渗流溃坝等灾害,进而形成溃坝洪水,威胁下游安危(图12)。可见在黄土沟谷灾害链形成、演变过程中,黄土的侵蚀都起到了十分重要的作用。当前对黄土物理力学等工程地质性质关注较多,对不同水动力作用下黄土侵蚀性评价,土体空间侵蚀变异性及侵蚀机制研究不足。

图 12 黄土沟谷型灾害链演变过程

Fig. 12 Evolution processes of gully disaster chain in loess

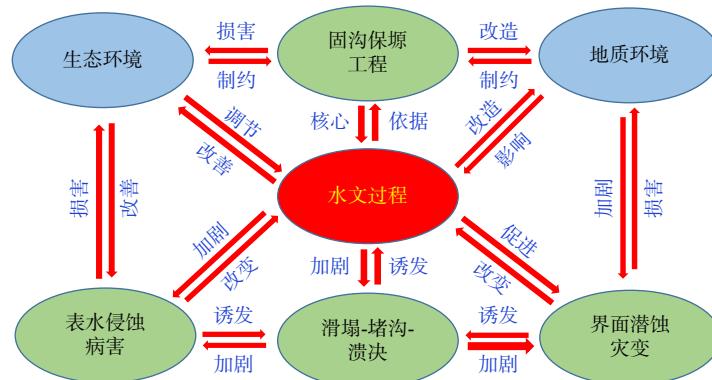
的人类工程活动,其核心是对塬边沟头水文过程的调控,水文过程的人为调控又与黄土塬边沟谷中各类水土侵蚀病害、灾害等密切相关。当前,对水动力作用下各类灾害或病害的形成机理研究较多,但是由于固沟保塬工程系统的复杂性,尚未能充分考虑固沟保塬工程与生态环境、地质环境之间的互馈作用。因此,在未来需要以地球系统科学理论为指导,深入研究工程-水文、工程-环境、水文-灾害、生态-灾害等之间的互馈作用机制,紧扣水文过程这一核心主题,将固沟

保塬工程中各类灾害有机联系起来(图 13)。

图 13 固沟保塬工程-生态环境-地质环境互馈作用

Fig. 13 Interaction between engineering, ecological environment, and geological environment in the GCHP
